CALSPAN ON-SITE AIR BAG DEPLOYMENT INVESTIGATION

CALSPAN CASE NO. 91-12

FLEET - 1990 DODGE SHADOW

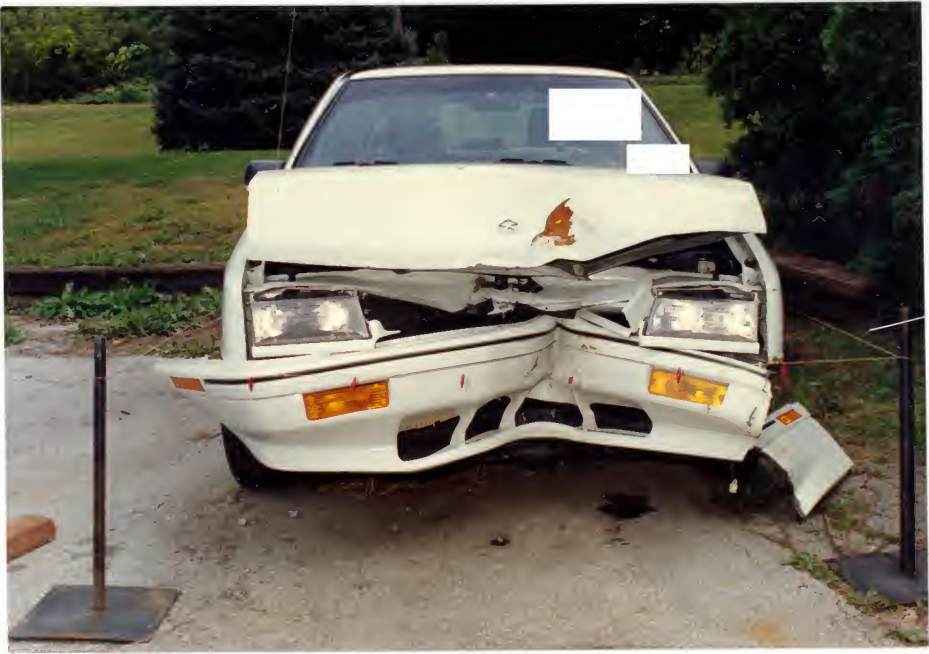
8

The center frontal area of the Dodge Shadow impacted the 10" diameter utility pole which resulted in moderate damage to the vehicle. Maximum crush was 14.5" located on the bumper reinforcement bar 4.75" left of center. Direct contact damage on the bumper fascia began 26.25" inboard of the right corner and extended 8.75" to the left. The impact deformed the entire width of the front bumper reinforcement bar resulting in a combined induced and direct contact damage length (Field L) of 48.0". Crush values at bumper level were as follows: $C_1=0.25"$, $C_2=5.75"$, $C_3=13.25"$, $C_4=7.4"$, $C_5=2.25"$, $C_6=0.0"$.

Frontal Damage To The Dodge Shadow.

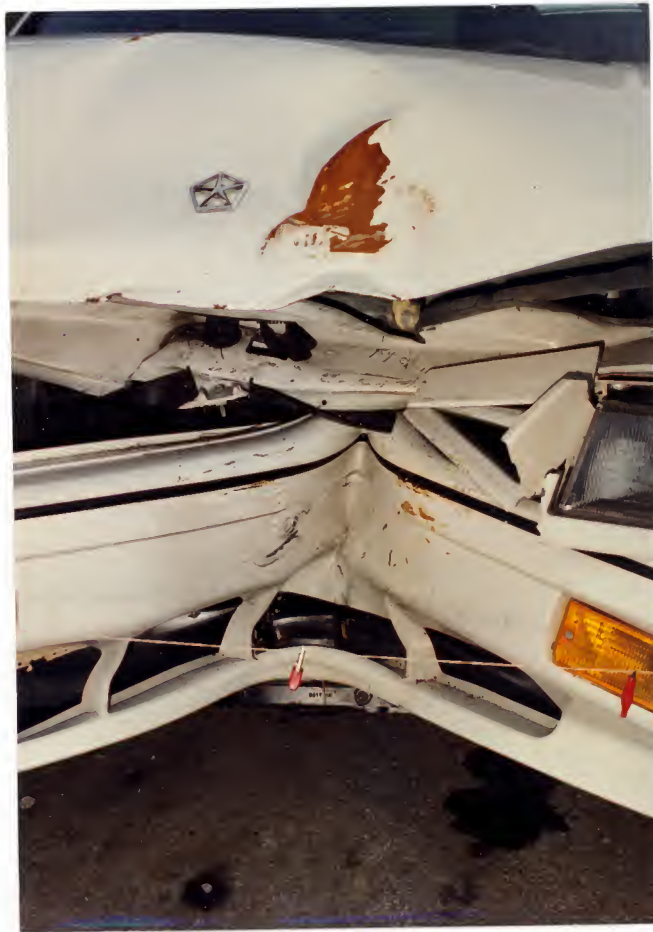
9

Closeup View Of The Center Frontal Utility Pole Impact Damage.

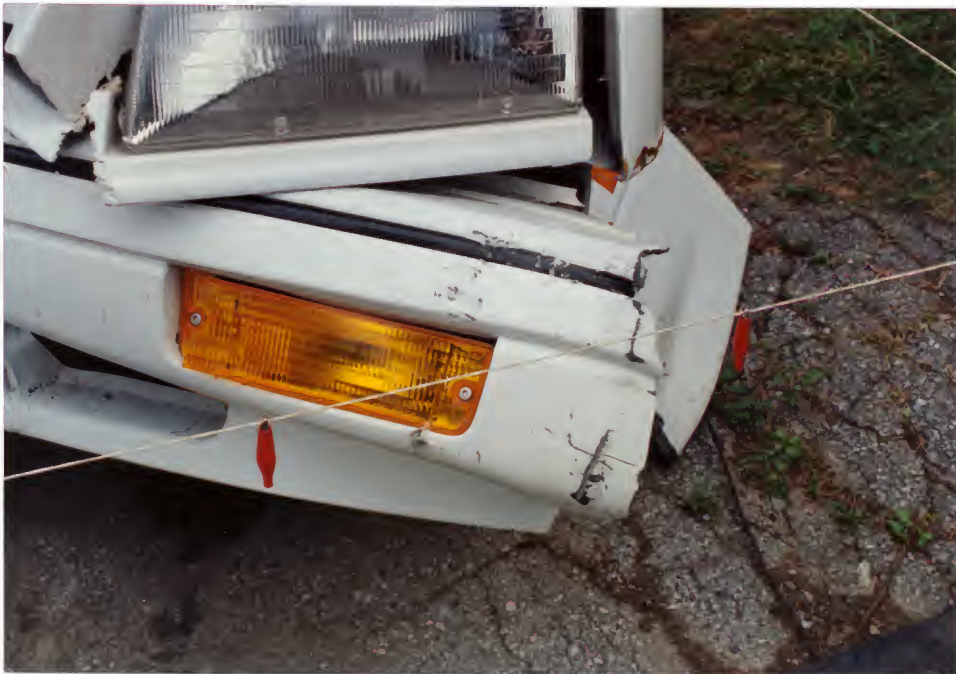
11

The vehicle continued forward and impacted a second concrete fence post with the left corner area of the front bumper. Direct contact damage began at the bumper corner and extended 5" inboard onto the bumper fascia. The concrete post impacts separated the left corner wrap-around of the bumper fascia. The extent of bumper crush was minimal, but unknown due to the bumper displacement from the utility pole impact.

Closeup View Of The Second Fence Post Impact Damage To The
Left Bumper Corner Area.

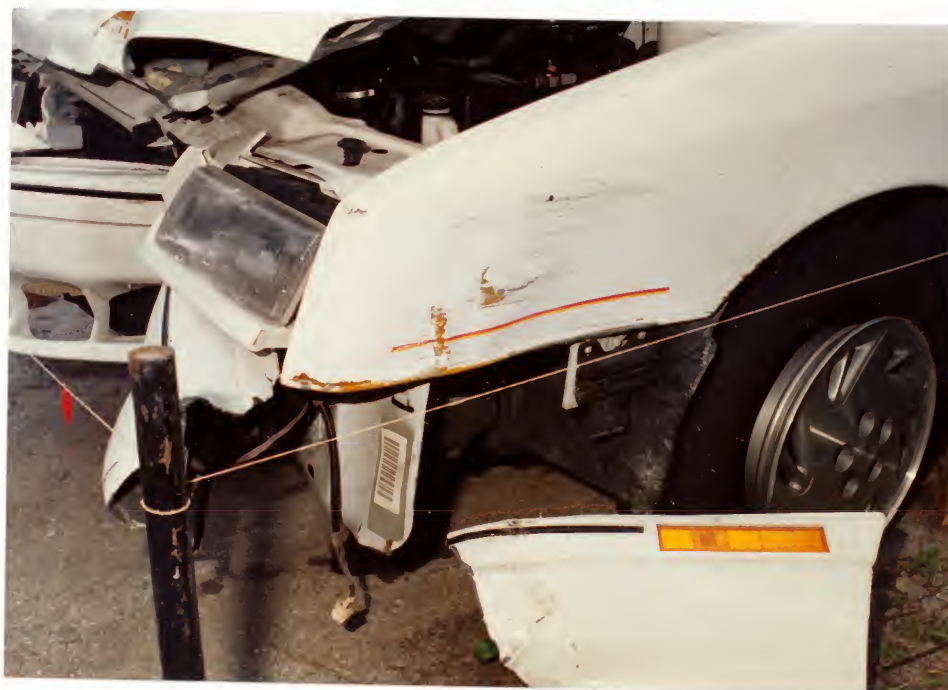
12

The left front corner area of the vehicle initially side-swiped the first fence post that was located 8'2" south of the south road edge. Damage to the vehicle was minimal which involved a shallow dent to the front third of the left front fender with paint abrasions. The damage extended 23.75" rearward on the fender before ending at a point 7.75" forward of the left front axle. The left front tire probably impacted the fence post which resulted in an airout of the tire. There was no visible damage to the tire or alloy wheel.

Fence Post Sideswipe Damage To The Left Front Fender Area.

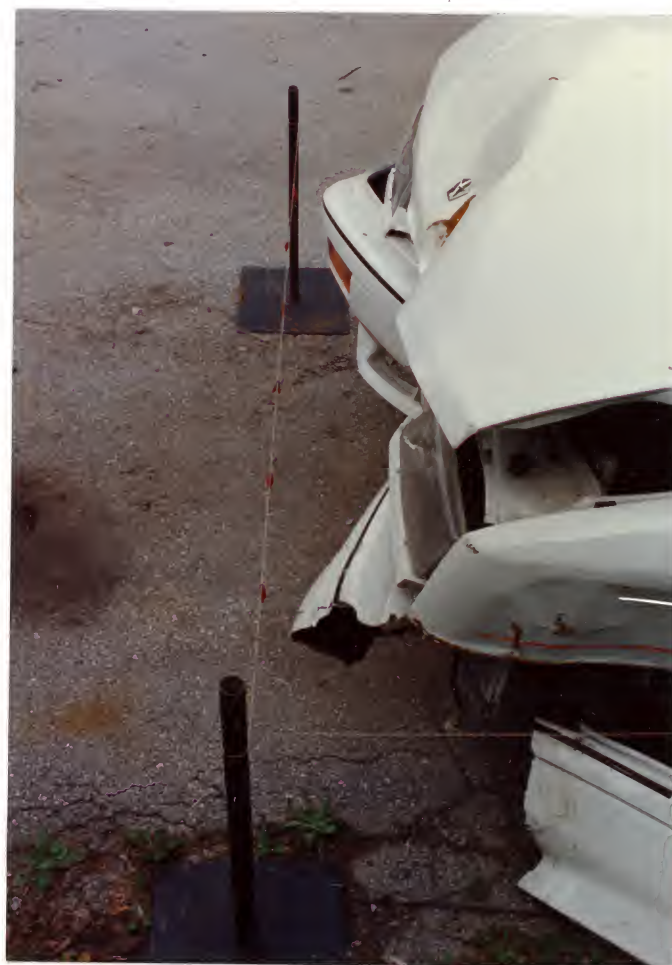
13

Left Perpendicular View Of The Frontal Area Showing
The Extent Of Bumper Crush.

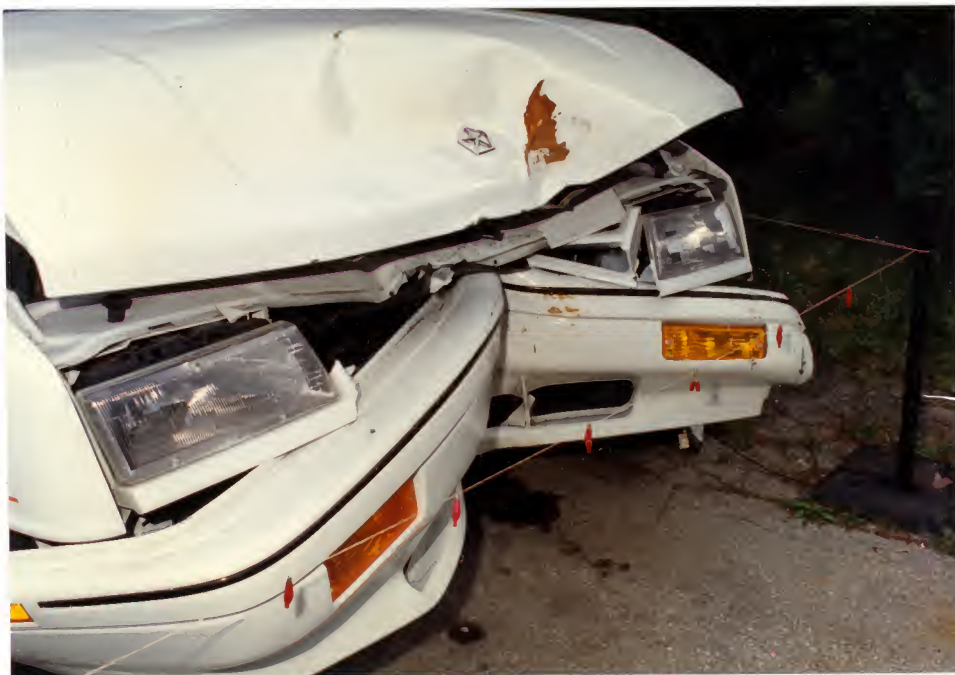
17

Angular View Of The Utility Pole Impact Damage.

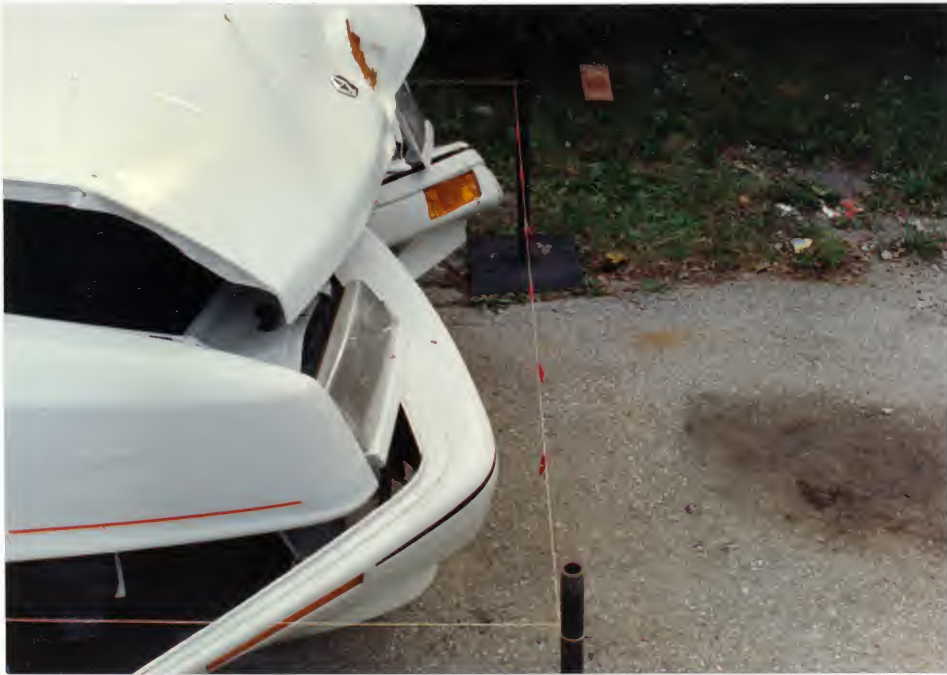
18

Perpendicular View From The Right Corner Showing The Extent of Frontal Crush.

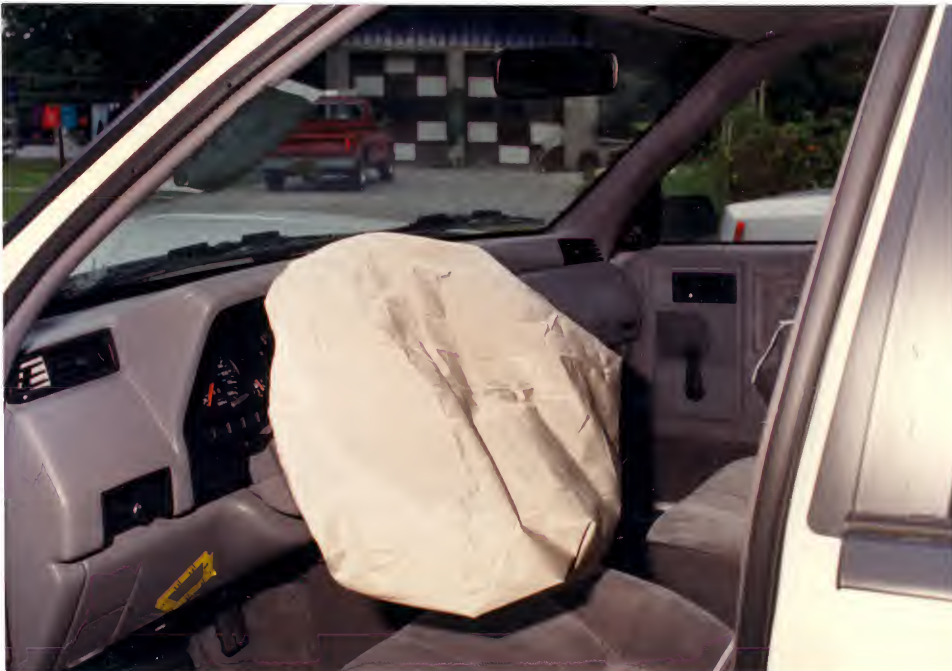
19

Interior: The interior of the Dodge Shadow sustained minor damage that was associated with air bag deployment and driver contact with interior components. As the air bag deployed, its deployment space was limited by the forward position of the driver. Her subsequent loading force was transmitted through the bag and into the steering assembly which deformed the upper steering wheel rim approximately 0.25" forward. The driver's loading force, in probable combination with air bag deployment, compressed the energy absorbing steering column 1.6". Shear capsule compression was measured at 1.375" on the left unit and at 1.6" on the right. The right shear bracket was completely disengaged from the block.

Overall Interior View Of The Driver's Contact Point And Deployed Air Bag.

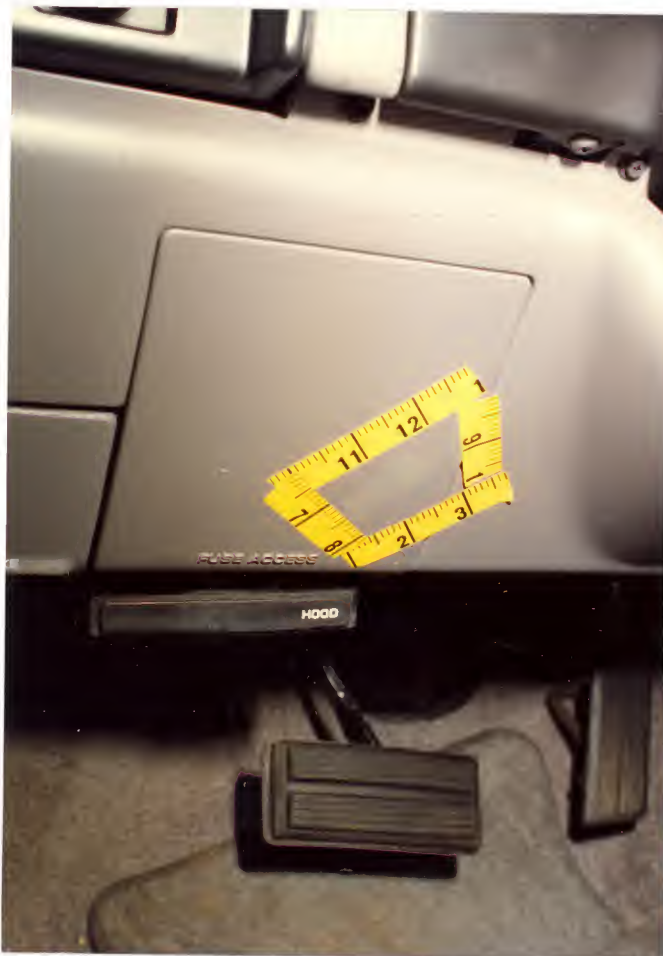
21

The driver's knees contacted the rigid knee bolster which resulted in injury to both knees; however, only the left knee produced contact evidence. A nylon stocking transfer was noted to the fuse box cover 17.75-19.75" left of center and 15-17" below the upper instrument panel.

Left Knee Nylon Stocking Transfer To The Fuse Box Cover In The Knee Bolster.

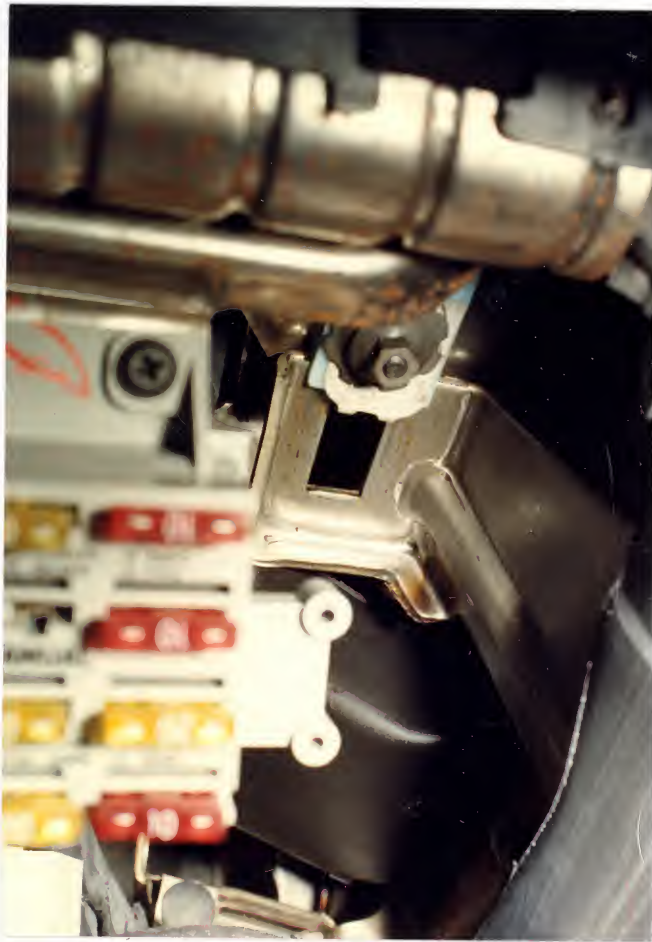
24

Left Steering Column Shear Capsule, 1.375" of Compression.

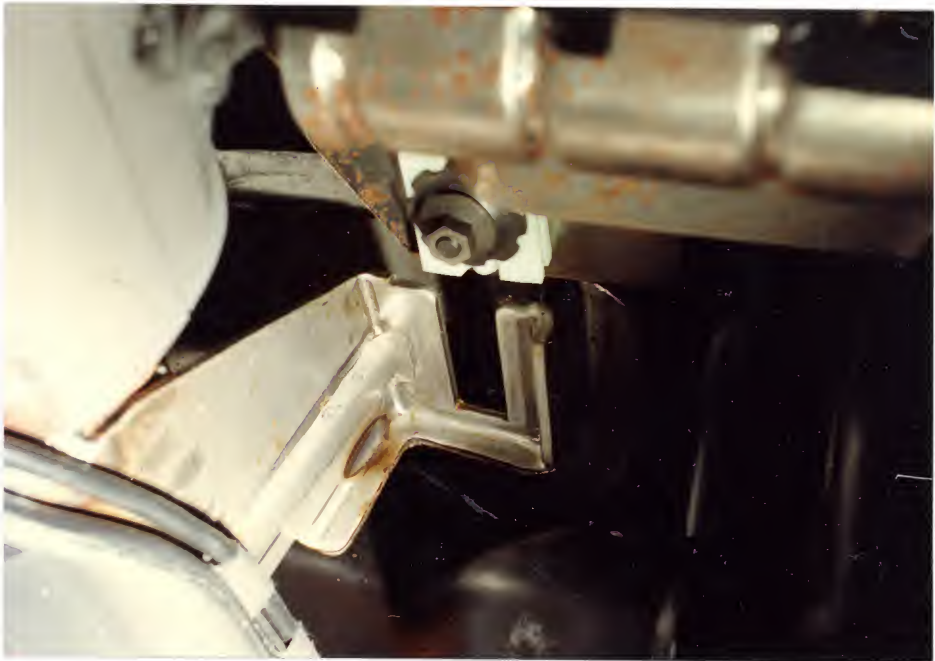
25

Right Steering Column Shear Capsule, 1.625" of Compression.

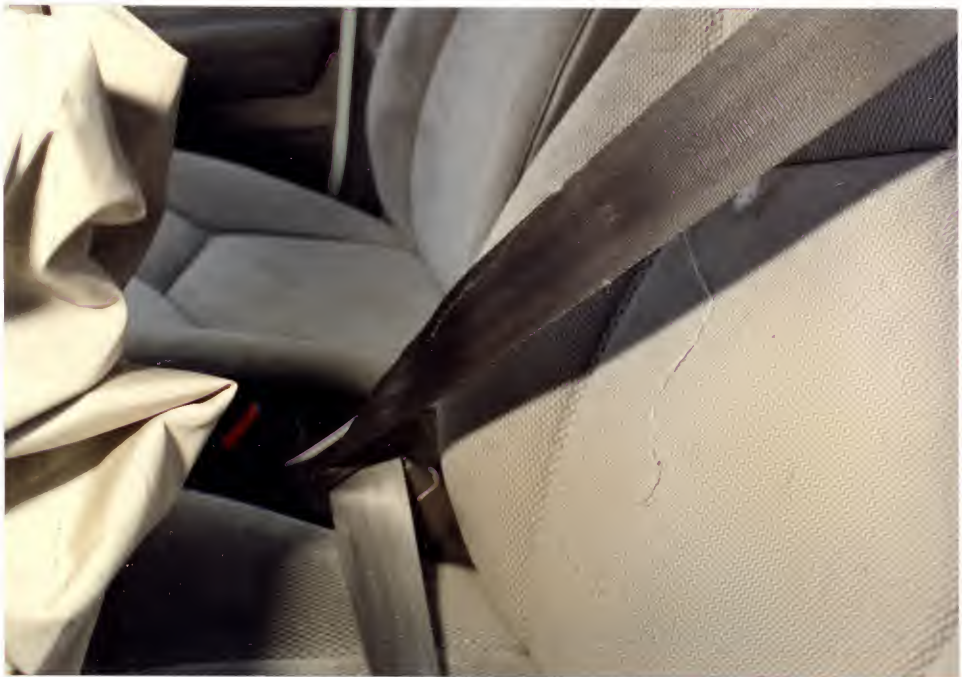
27

The driver was wearing the active 3-point lap and shoulder belt system at impact; however, due to her forward position, did not sufficiently load the belt webbing. There were no load induced stretch marks on the belt webbing or at the B-pillar mounted D-ring. The latchplate did yield several faint routine wear marks which indicated that the driver was a frequent, but not full-time belt user. As the driver slumped to her right following the impact sequence, a jewelry pin that was affixed to the left side of her dress snagged the shoulder belt webbing. The snags were located on the outside surface of the shoulder belt webbing and extended 22-26" and 30.25-36.75" vertically above the floor mounted anchor. Both snags were located .375" inboard of the belt edges. A third snag was located at both edges of the belt 36.75" above the floor anchor. The snag resembled superficial cuts at the edges and contained cloth fibers (probable dress fibers).

Snags On Outside Surface Of Belt Webbing.

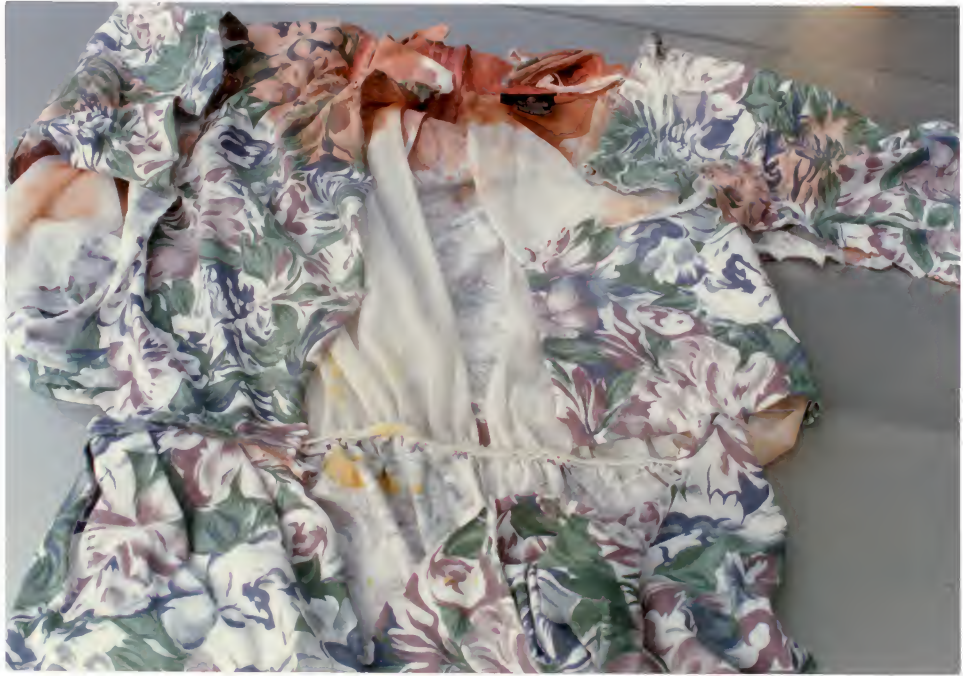
30

Vertical Tear To The Top Of The Dress.

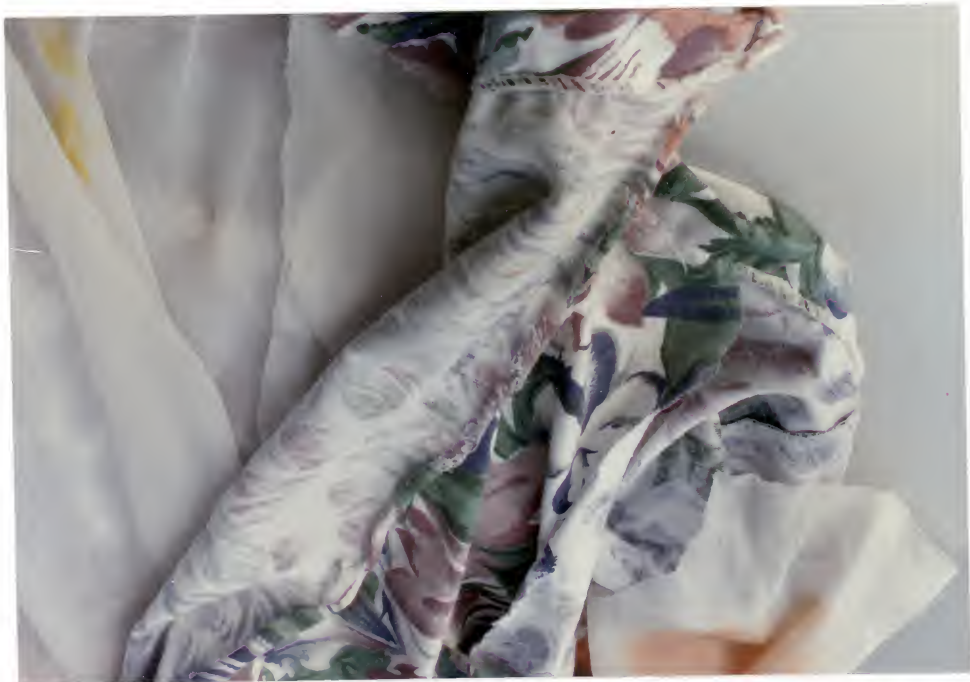
31

Torn Right Side Of Dress.

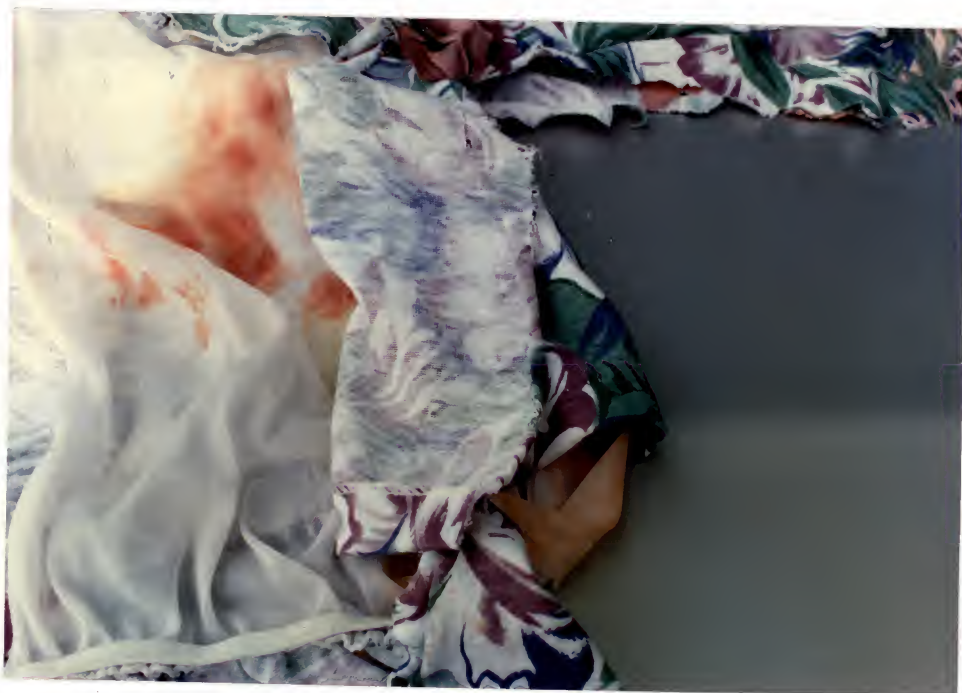
Torn Left Side Of Dress.

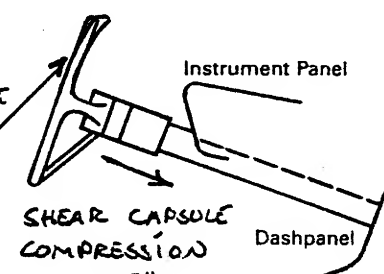
~.25" OF
UPPER RIM
DISPLACEMENT

SHEAR CAPSULE
COMPRESSION
L = 1.375"
R = 1.625"

THORACIC/AIR BAG
BENDING OF UPPER RIM

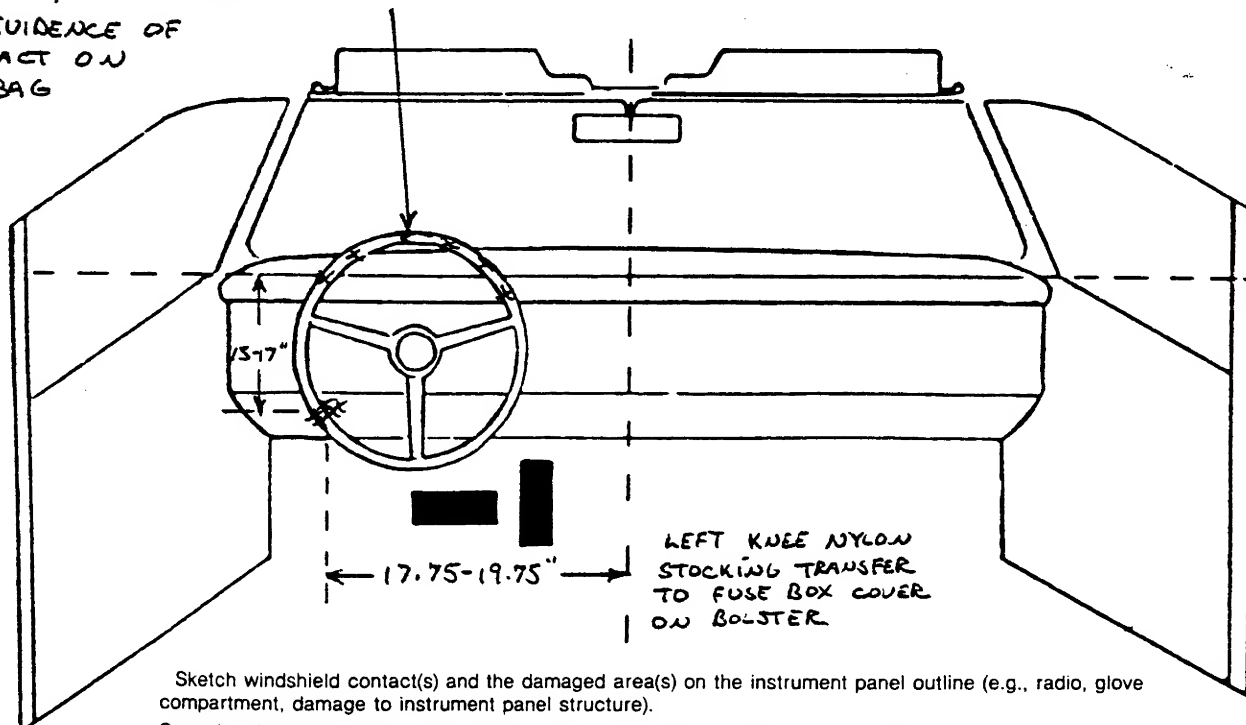
NO EVIDENCE OF
CONTACT ON
AIR BAG

LEFT KNEE NYLON
STOCKING TRANSFER
TO FUSE BOX COVER
ON BOLSTER
